## General Information

Wigo 024 PP-2BW-0934 44,824km Service regular Inquiry trade in not sure Raize or YC yet Scratch front bumper RH medium ( ) Scratch front door RH medium ( ) Scratch rear fender RH small Scratch rear bumper and dent rear and front door LH Scratch front bumper Scratch hood ( ) Stone chip glass windshield Cleaning 1 EST RC \$500

| Inspection Date | September, 28 2026 | Vehicle Type | Toyota HATCHBACK undefined 2024 |

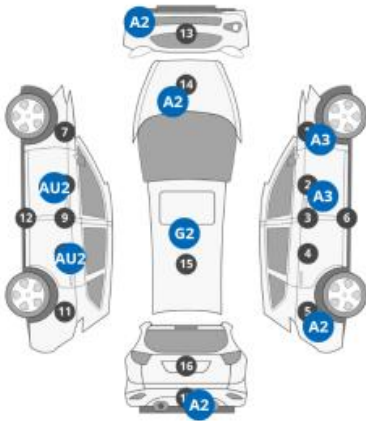
## Illustration Damage

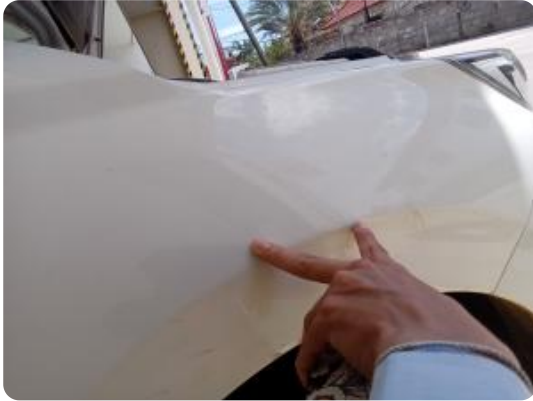
| Area | Parts Name | Damage Name | Damage Level |
|---|---|---|---|
| | (R) Front Fender | Scratch | Medium |

(R) Front Fender - Scratch

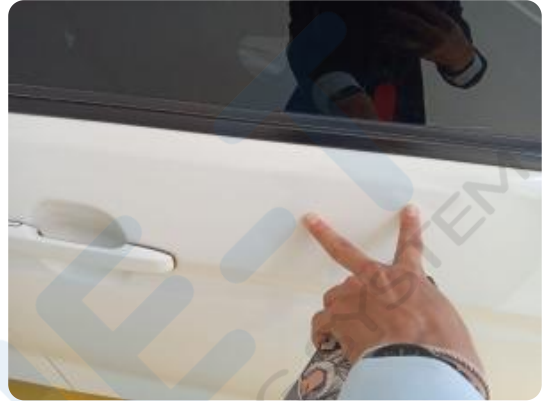
| Area | Parts Name | Damage Name | Damage Level |
|---|---|---|---|
| | (R) Front Door | Scratch | Medium |

(R) Front Door - Scratch

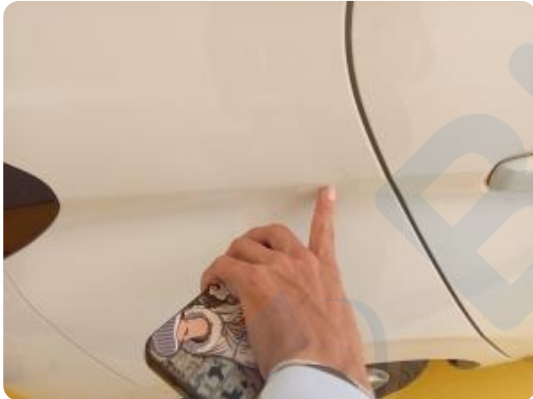
| Inspection Date | | September, 28 2026 | Vehicle Type | | Toyota HATCHBACK undefined 2024 |
|---|---|---|---|---|---|
| | (R) Rear Fender | Scratch | | Small | |

(R) Rear Fender - Scratch

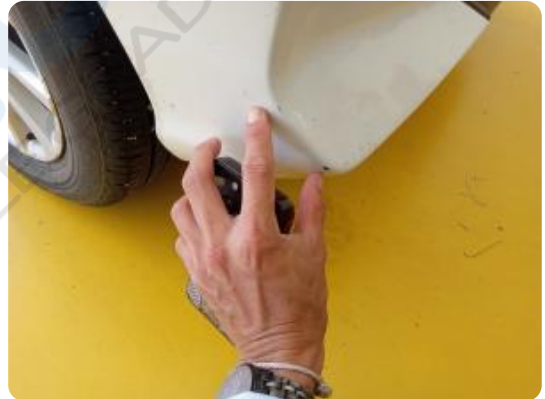
| Inspection Date | | September, 28 2026 | Vehicle Type | | Toyota HATCHBACK undefined 2024 |
|---|---|---|---|---|---|
| | Rear Bumper | Scratch | | Small | |

Rear Bumper - Scratch

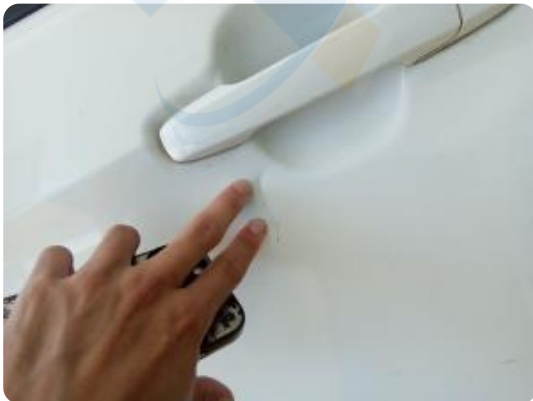
| Inspection Date | | September, 28 2026 | Vehicle Type | | Toyota HATCHBACK undefined 2024 |
|---|---|---|---|---|---|
| 10 | (L) Rear Door | Scratch & Dent | | Small | |

(L) Rear Door - Scratch & Dent

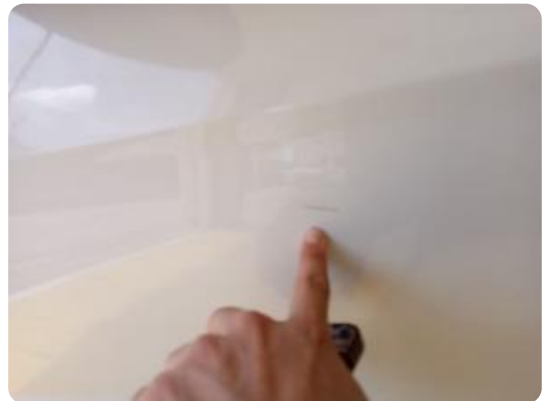
| Inspection Date | | September, 28 2026 | Vehicle Type | | Toyota HATCHBACK undefined 2024 |
|---|---|---|---|---|---|
| | (L) Front Door | Scratch & Dent | | Small | |

(L) Front Door - Scratch & Dent

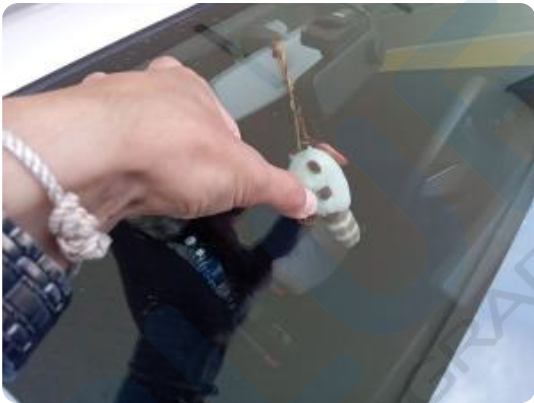
| Inspection Date | | September, 28 2026 | Vehicle Type | | Toyota HATCHBACK undefined 2024 |
|---|---|---|---|---|---|
| | Front Windshield | Scratch, Stone chip | | Small | |

Front Windshield - Scratch, Stone chip
