| Registration No. | PP-2BM-5594 | Transmission | Automatic |
| Model | Corolla Cross | Fuel Type | Petrol |

## Overall Evaluation

| Inspection Date | October, 02 2026 | Vehicle Type | Toyota SUV undefined 2021 |

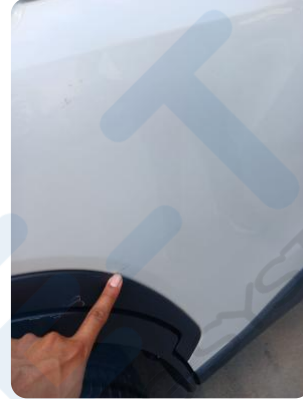
| Area | Parts Name | Damage Name | Damage Level |
|---|---|---|---|
| 4 | (R) Rear Door | Scratch | Minimal |

(R) Rear Door - Scratch

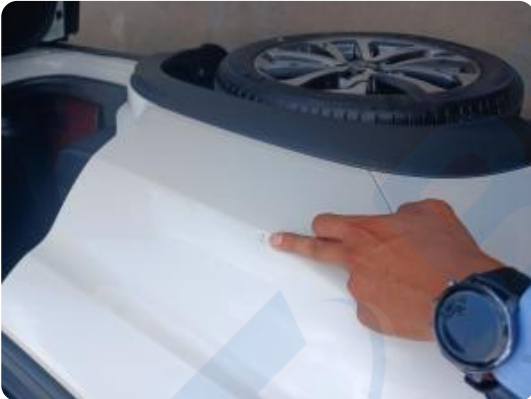
| Area | Parts Name | Damage Name | Damage Level |
|---|---|---|---|
| | (R) Rear Fender | Dent | Minimal |

(R) Rear Fender - Dent

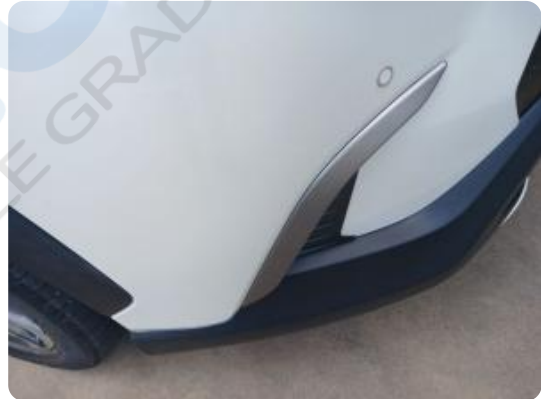
| Area | Parts Name | Damage Name | Damage Level |
|---|---|---|---|
| | Front Bumper | Scratch | Minimal |

Front Bumper - Scratch

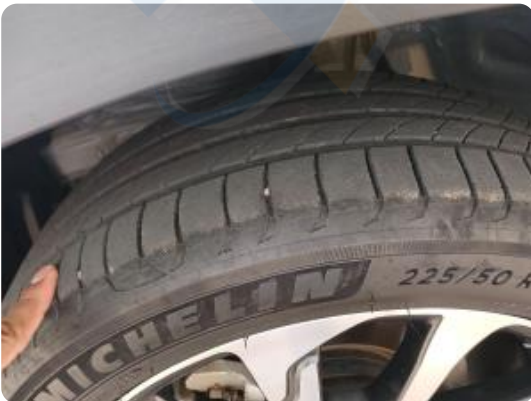
| Area | Parts Name | Damage Name | Damage Level |
|---|---|---|---|
| 7 | (L) Front Tyre | Crack, Cut | Yes |

(L) Front Tyre - Crack, Cut

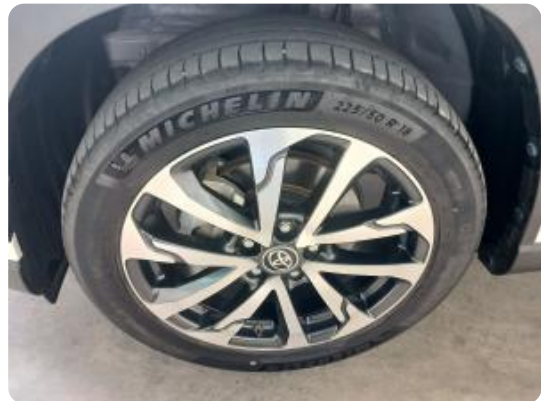
| Area | Parts Name | Damage Name | Damage Level |
|---|---|---|---|
| | (R) Front Tyre | Crack, Cut | Yes |

(R) Front Tyre - Crack, Cut
