Registration No.	PP-2BX-0210	Transmission	Automatic
Chassis No.	MHKAA1BCX0J006449	Model Year	2024
Engine No.	1KR-A828385	Colour	White
Make	Toyota	Location	DTP
Model	Wigo	Fuel Type	Petrol
CC	undefined	Mileage	31,006
Grade	Great	Expiry Inspection License	
Type of Body	HATCHBACK	Expiry - Insurance

Inspection Date	October, 01 2026	Vehicle Type	Toyota HATCHBACK undefined 2024
Location	DTP	Registration no	PP-2BX-0210

BLUE-T VEHICLE GRADING SYSTEM

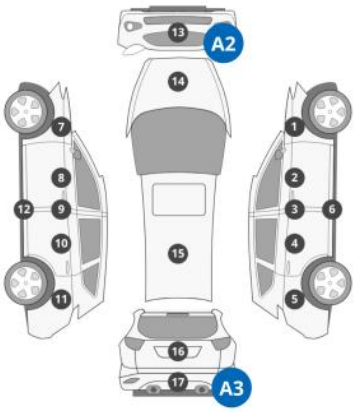
estimate 300$ recondition clean 1set, scratch rear and front bumper .

Area	Parts Name	Damage Name	Damage Level
12	(L) Step	-	-
	In-panel	-	-
	Side Spoiler	-	-
13	Front Panel	-	-
	Member (Bolted)	-	-
	Front Bumper	Scratch	Small
	Grille	-	-
	Lamps	-	-
14	Bonnet	-	-
	Headlight	-	-
15	Roof	-	-
	Front Windshield	-	-
	Rear Windshield	-	-
	Roof Spoiler	-	-
	Molding	-	-
16	Trunk Hood, Rear Gate	-	-
	Antennae	-	-
17	Rear End Panel	-	-
	Muffler and Undercarriage Parts	-	-
	Rear Bumper	Scratch	Medium
	Lamps	-	-
	Panels	-	-
